THE RESULT OF MONITORING IN FRANCE

The concept

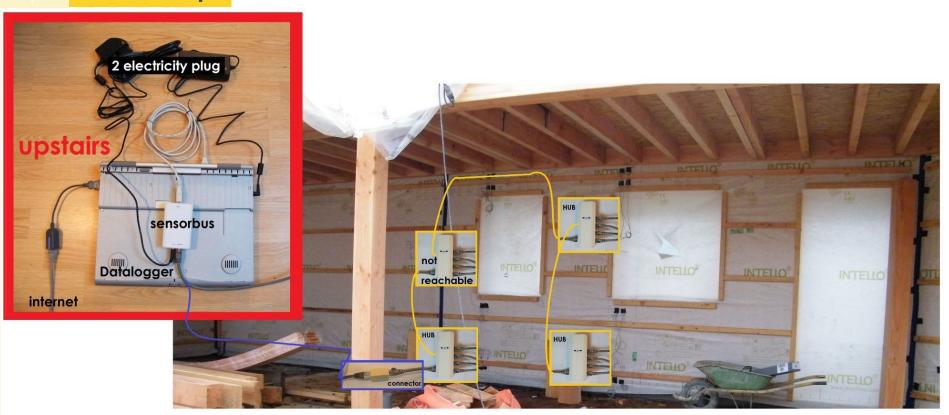
- 2 instrumented walls
- 2 instrumented building

8 sensors by wall

an internet connection to recover data
